Repair of High Partial Discharge Value due to End-Winding Stator Generator Vibration: a case study

Edo Angga Radita
(MSU) Maintenance Service Unit
PT. Indonesia Power
Jakarta, Indonesia
edo.angga@indonesiapower.co.id

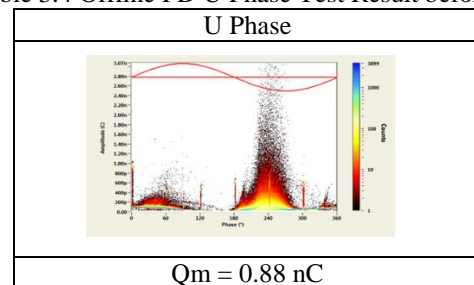
Table 3.4 Offline PD U Phase Test Result before Repair

The result of the test and best practice analysis based on literature pattern was discharge in end winding.^[9] There was exceeded best practice standard partial discharge on T phase which is counted on 135,68 nC magnitude.

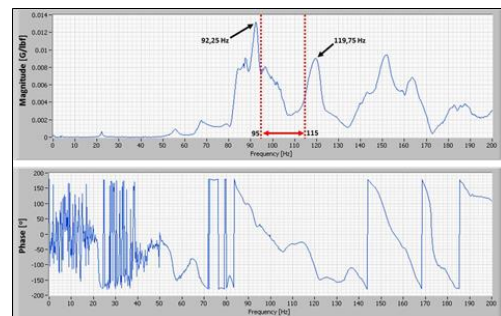
Frequency Response Function curve of end winding test result on turbine side and exciter side can be seen in figure 3.4 and 3.5. On the figure, we can see there are two natural frequencies in turbine side, which are 92,25 Hz and 119,75 Hz. There are also two in exciter side, which are 69 Hz and 102,75 Hz. Both of natural frequencies in turbine side was beyond 95 – 115 Hz range, and only one natural frequency in exciter side was on the range, with 102,5 Hz.^[10]

Figure 3.4 FRF Test Curve of End Winding Turbine Side

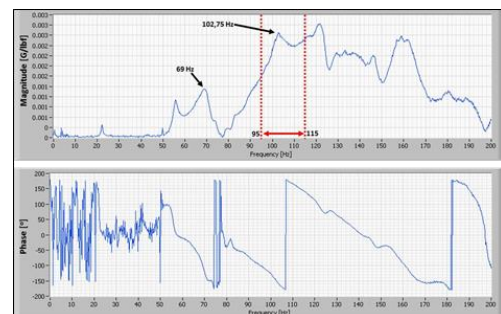
Figure 3.5 FRF Test Curve of End Winding Exciter Side

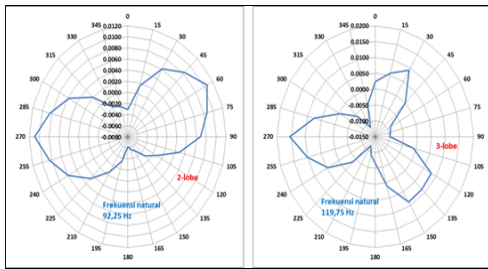
115 Hz range. Vibration modes on each natural frequency can be seen in figure 3.6 and 3.7. We can see that ellipse shape end winding vibration modes is under or beyond 95 - 115 Hz range. It means that there is only small chance of end winding resonance phenomenon which can add looseness is formed. After tightening the end winding ties, we can amplify the conclusion that generator 2.3 is safe to operate.

Figure 3.6 End Winding Turbine Side Vibration Modes

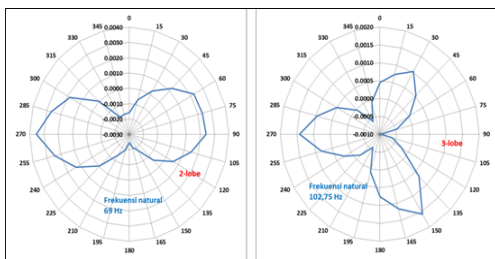
Figure 3.7 End Winding Exciter Side Vibration Modes

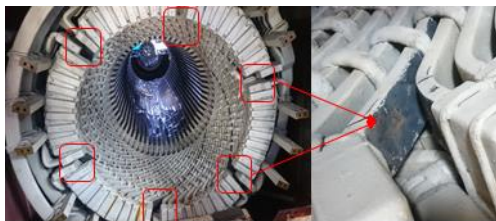
Figure 3.8 Connection phase without varnish

We found that there were corona discharge tracing and higher PD offline test result than standard. We planned to repair corona protection coating in end winding area. First step to do was wiping out varnish in face to face connection phase which is seen in figure 3.8. Connection phase is an area in end winding which has high difference potential voltage. The purpose of wiping out varnish were to see gradient design of corona protection coating from manufacture and to make new corona protection coating sticking perfectly in corona protection coating for long time.

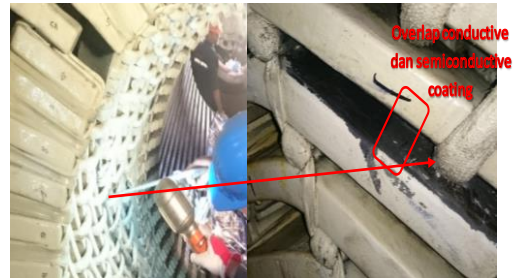
Figure 3.10 Application of varnish in corona protection semi conductive coating

There were two anti-corona coating, the first was conductive varnish which is located in the tip of slot core end stator showing in figure 3.9. The second was semi conductive coating which is located after conductive coating until end cap showing in figure 3.10. We need to pay attention to critical point which is around 2 cm between conductive coating and semi conductive coating especially the cleanliness of the surface in order to develop perfect contact.
